## Case Study: Seamless Flooring Systems

# Providing a solution to Biffa Waste's deteriorating expansion joints

Client: Biffa Waste Depot

Projects: Replace Deteriorating Expansion Joints

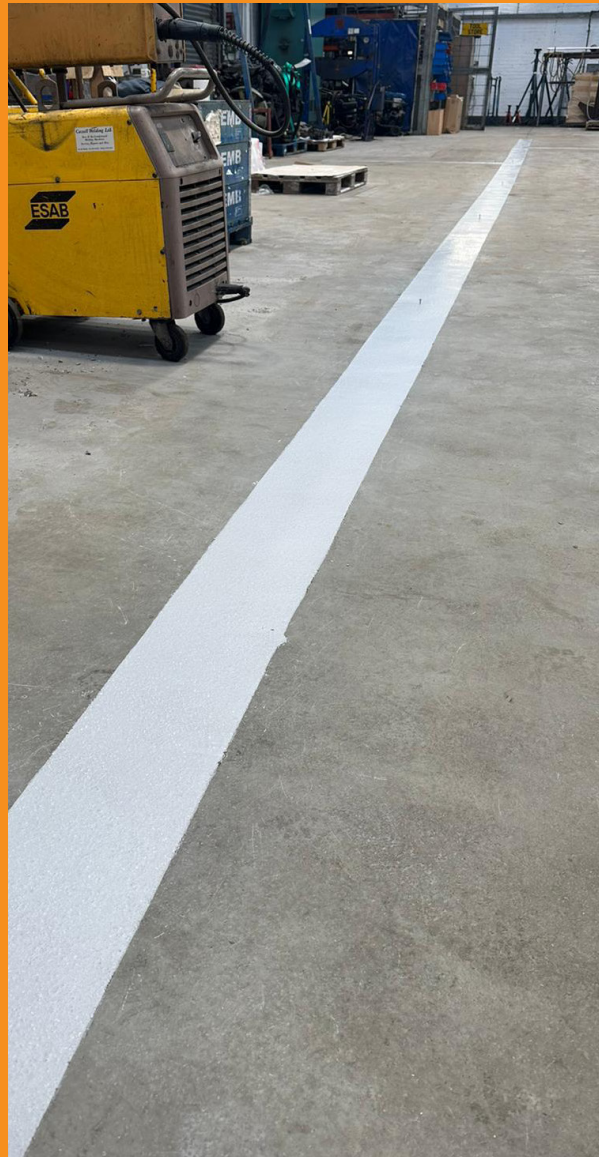
Biffa Waste Depot was experiencing a problem with its existing flooring, due to heavy duty use over the years. Deteriorating expansion joints were creating hazards for both foot and wheeled traffic and a solution was required that would involve minimum disruption to the daily workload.

The solution comprised a number of stages. Initially, we saw-cut the defective joints on either side to form a neat edge. The next task was to mechanically break out the concrete and old jointing compound to form a rebate approximately 200mm wide. After this, we supplied and laid Vebro polyurethane screed to the prepared rebates, trowelling to match the surrounding profiles.

Once the screed was cured, we were able to saw cut and introduce new expansion joints and fill, using Pumexpand jointing compound. While Pumexpand allows for movement within the joint, it is designed to be strong enough to protect the edges of the new joint.

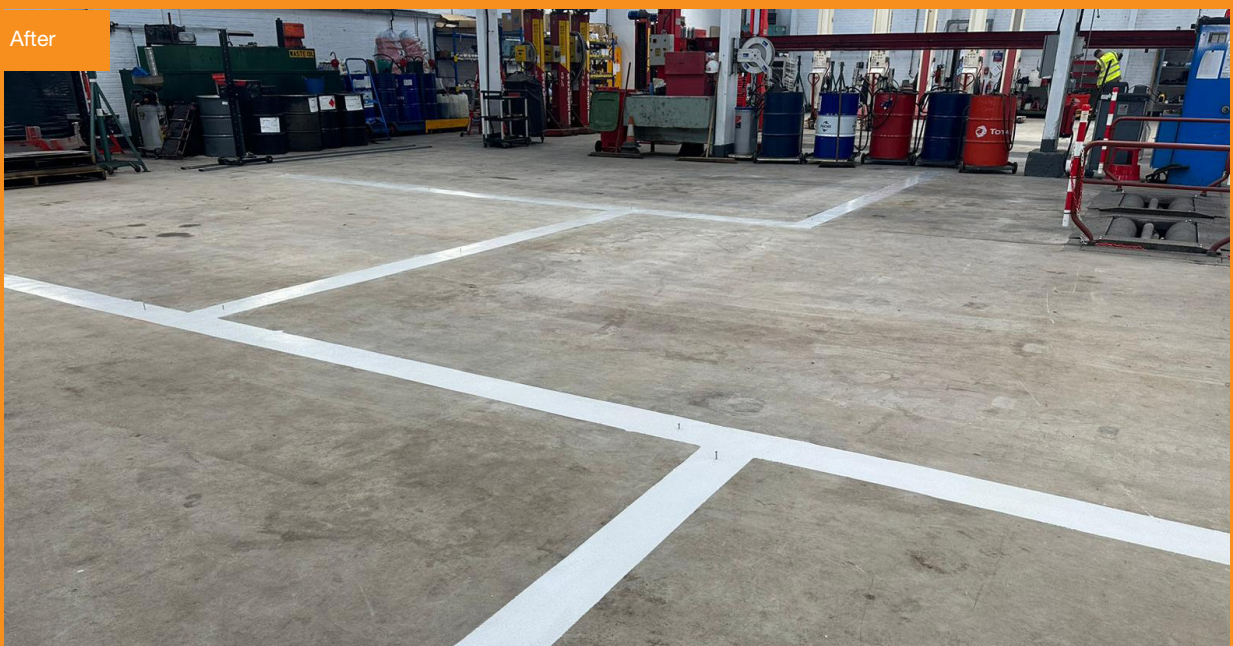
After

The result is a robust flooring repair that is strong enough to withstand heavy usage for many years to come, using advanced materials and installation methods that meet the requirements of the brief, providing a solution that is neat, easy to maintain and fit for purpose, ensuring the safety of operatives and safe usage of equipment.
