## Case Study: Grounds Maintenance

# Complete Boundary Fencing Replacement for Housing Association

Project: Replacement of Damaged Boundary Fencing

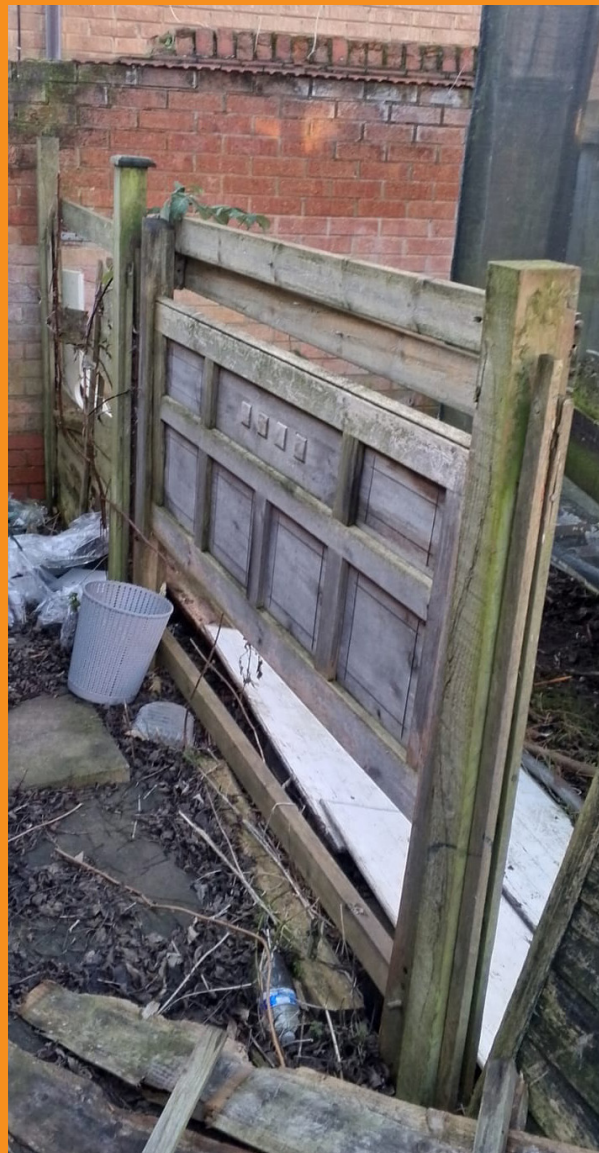
The project began with the removal of the existing damaged and mismatched fencing. Materials were cleared from the site and disposed of appropriately, allowing the boundary to be prepared for the new installation.

A new 1.8m-high fencing system was then installed along the approximately 20-metre boundary.

The new system comprised overlap timber fence panels, precast concrete posts and concrete gravel boards, combining the appearance and practicality of timber fencing with durable supporting components.

Concrete gravel boards separate the timber panels from ground level, while the precast concrete posts provide a strong supporting structure. Together, the components provide a practical fencing system suited to a residential environment.

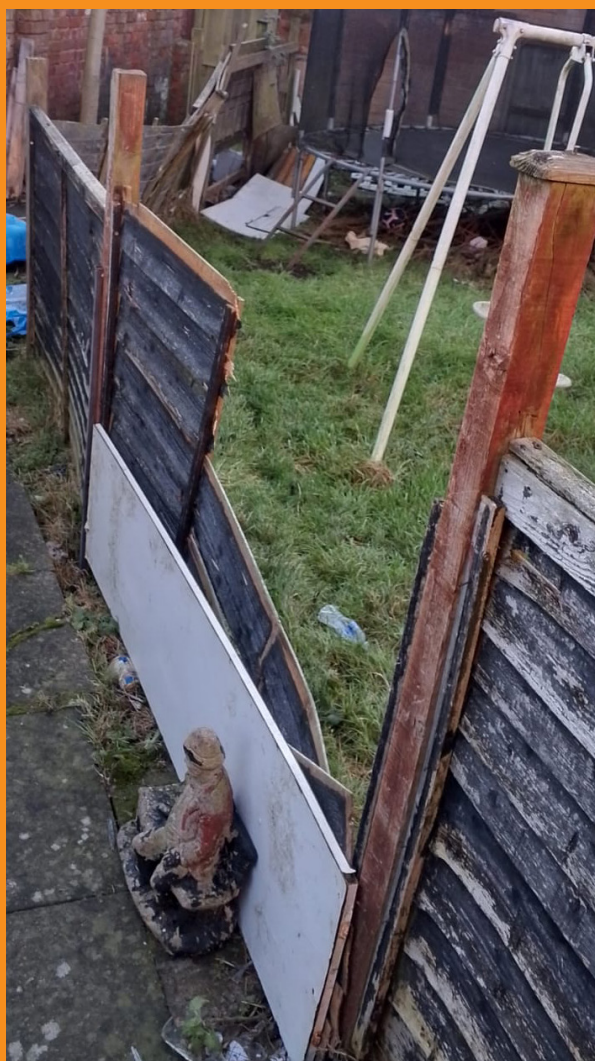
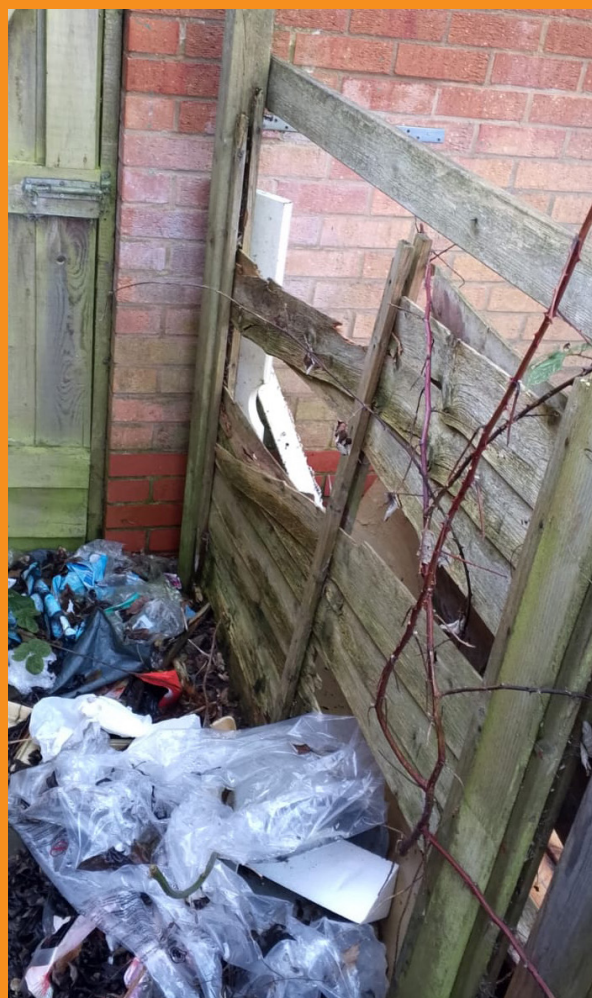
Before

Approximately 20 metres of boundary fencing at a housing association property had become damaged and consisted of mismatched sections that no longer provided the consistent, secure boundary required.
