## Case Study: Seamless Flooring Systems

# Refurbishment Facility

Area Coverage: 5200 Square Metres

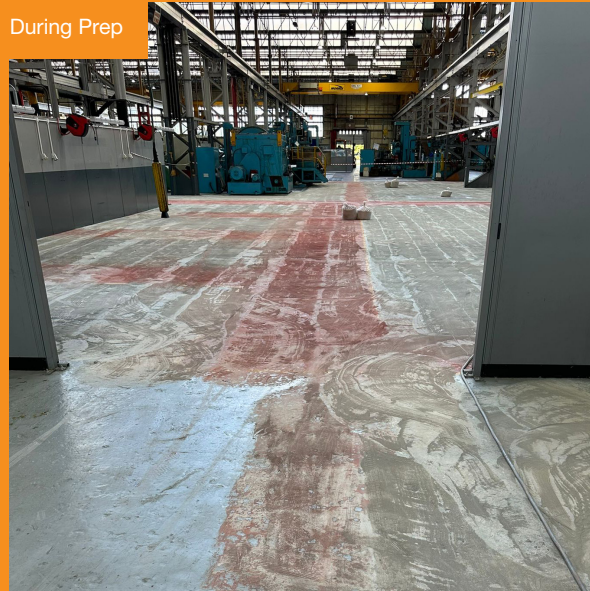
During Prep

The job called for the removal of existing floor coatings and surface contamination, to provide a clean, textured surface with good mechanical key. Zenith achieved this with the use of orbital diamond grinding equipment, using both handheld and upright machines. Minor repairs were also carried out using an epoxy resin mortar, trowelled in to match the existing profiles.

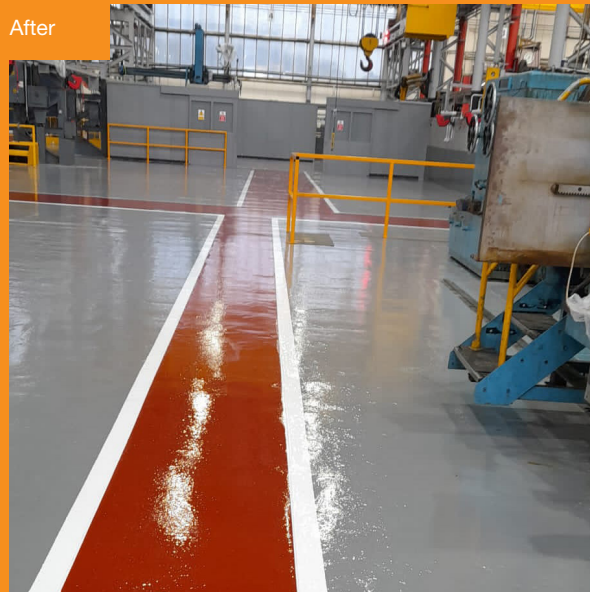
After

The tough finish was achieved by first applying one coat of an oil tolerant primer, followed by two coats of a high build epoxy resin coating, in colours agreed with the client, to form demarcation lines and zebra crossings.

The result is a strong, durable industrial flooring that looks fresh and clean. Thanks to the advanced materials and installation methods used, it has the capability to withstand many years of heavy, industrial usage and still maintain its appearance.
